**DRAFT OCCURRENCE REPORT  
DFS CYCLONE BIN ENCLOSURE INCIDENT  
OF  
30 APRIL 2000, EXTRACT**

**DFS Cyclone Bin Enclosure Incident of 4/30/00**

Occurrence Report No: 000430-C1 Action Level: 2

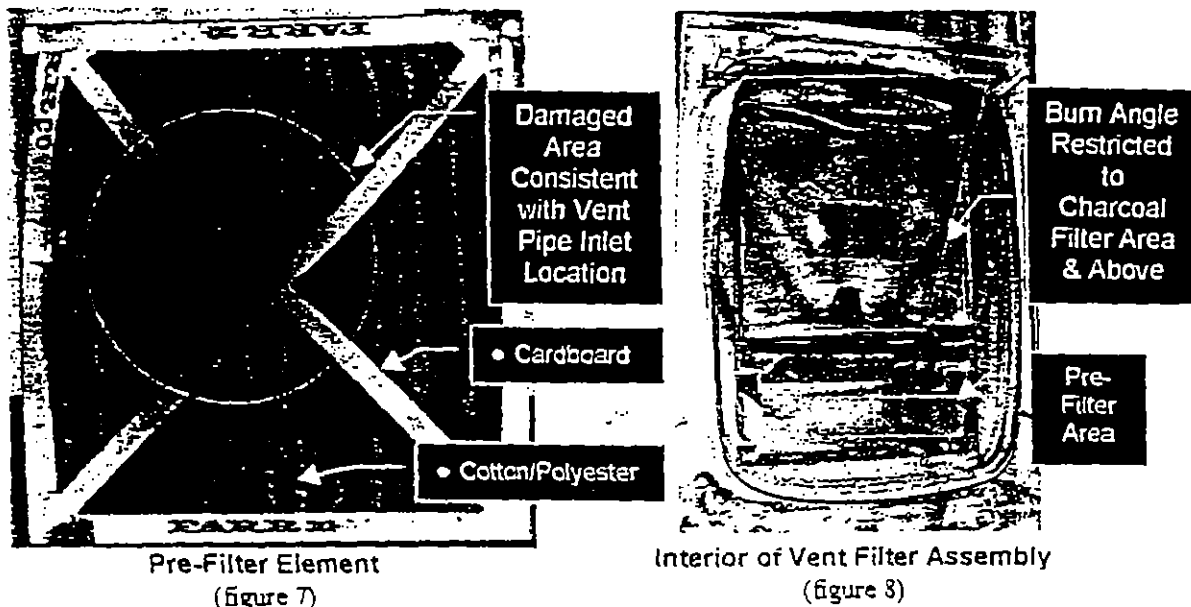
The pre-filter element, composed mostly of cotton & polyester, did not readily ignite (figure 7), but did indicate some degree of decomposition as a result of the hot gasses passing through the filter element. This filter media has a maximum useful temperature limit of 200°F (intermittent). And as it does show some minor degree of damage, it is evident that the inlet temperature exceeded this amount. This is consistent with the data, which showed that the temperature inside of the cyclone bin enclosure was sufficient to melt the polypropylene plastic material (i.e. >320°F). The lack of oxidized material is also supportive of the theory that most of the actual burning took place in the filter casing immediately downstream of this element.
